Property Inspection Report

**123 Your Street
Your Town, CA 94588
07/01/2009**

The Sample Report
123 Your Street My Town CA 94588

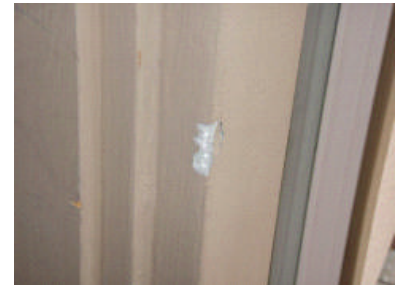
MAINTENANCE: There was damaged foam trim surfaces noted on the front side of the dwelling at the entry door. We recommend repair to prevent further deterioration. (See example picture in report body)

MAINTENANCE: The foam trim on the dwelling was noted to have cracking of the joints at many exterior locations. The installation appears to have used smaller piece and the bonding was poor. This is cosmetic from an inspection standpoint. The use of a urethane coating may help to improve appearances. Consult a coating specialist for advice.

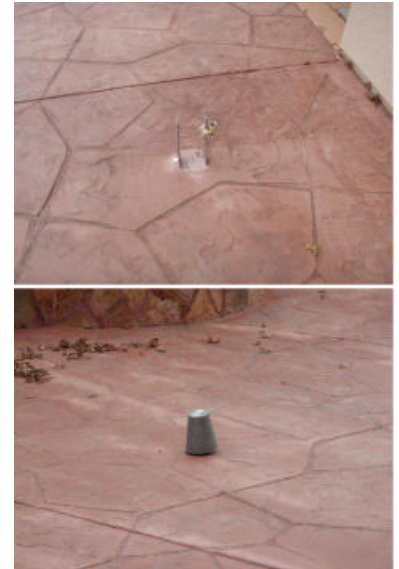
4.9 PATIO:

ACTION: [Safety item] There were post brackets and a pipe noted in the patio surface on the rear side of the dwelling. We recommend the bracket be covered or utilized to prevent accidental injury by falling on to it. (See example picture in report body)

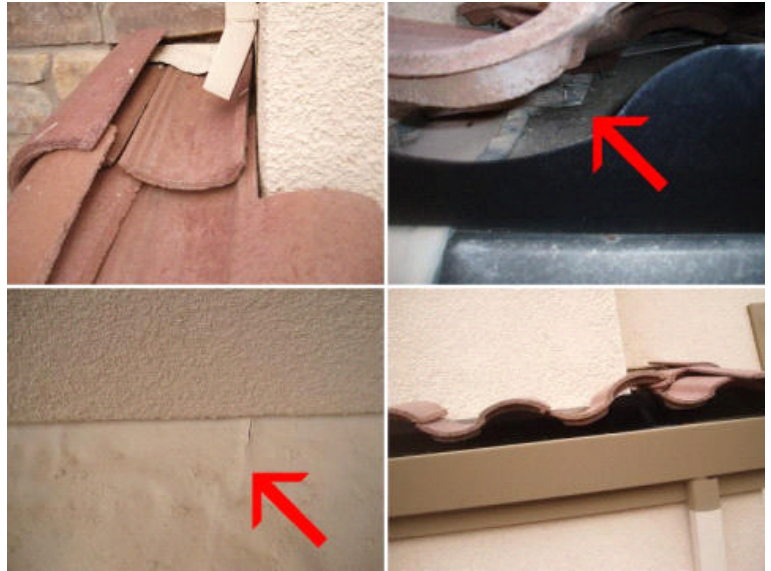
5.7 ROOF TILE:

ACTION: The tile roofing on the chimney shoulders was noted to be improperly installed. The tiles were loose and the sidewall flashings were improperly installed. There were torn sidewall flashings at other areas. We recommend evaluation and repair of the entire roof by a qualified roofing specialist. (See example picture in report body)

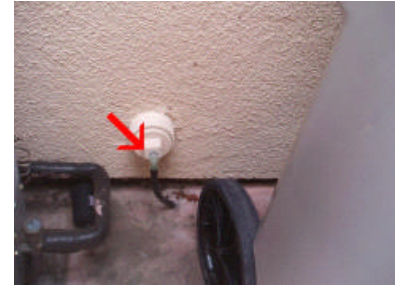
ACTION: [Safety item] The system drain piping was improperly installed with a plumbing cross connection. There was a direct connection to the sewer with no trap installed. We recommend repair by a qualified specialist. (See example picture in report body)

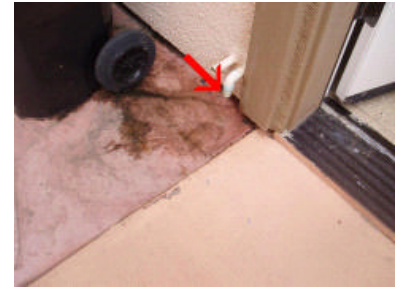
8.6 TEMPERTURE AND PRESSURE RELIEF VALVE:

ACTION: The temperature & pressure relief valve was leaking water from the discharge line. We recommend replacing the valve and installing an approved discharge line. (See example picture in report body)

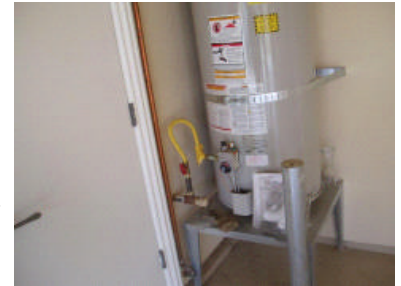
8.7 SEISMIC :

ACTION: The water heater seismic strapping was installed in a manner that did not meet the State Architect's requirements or the water heater strapping kit manufacturers instructions. The intent is for the water heater to resist movement. The lower strap was improperly located according to the straps installation instructions. The strap should be strapping in the lower third of the of the water heater but 4 inches from the controls. We recommend properly installing the straps according to the manufacturer's instructions and or industry standards. (See example picture in report body)

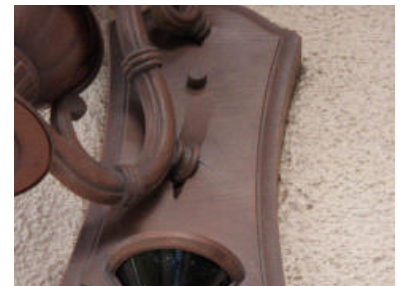
- 9.21 EXTERIOR LIGHTS/FIXTURES:** **ACTION: [Safety item]** A front exterior light fixture was damaged.
- SUGGESTION: A qualified technician should be retained to repair or replace the broken light fixture. (See example picture in report body)

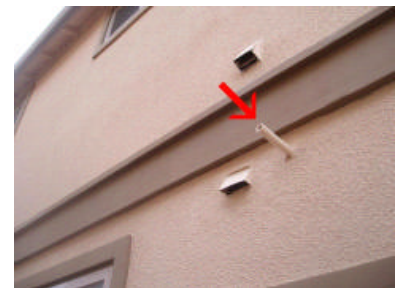
11.8 CONDENSATE LINE:

MAINTENANCE: The condensate line over flow discharge was missing a turn down. We recommend repair. (See example picture in report body)

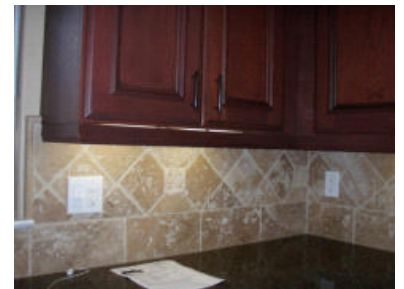
12.2 CABINET NOTE:

Note: The upper cabinet to the right of the sink had a gap at the base moulding that allowed the counter lights to be seen through. This is a cosmetic concern. Repair is optional. (See example picture in report body)

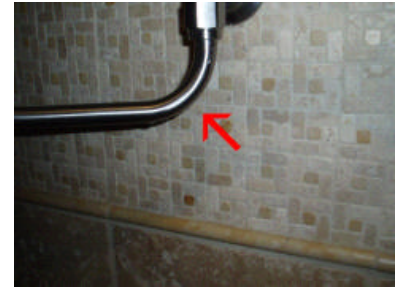
12.4 FAUCET:

ACTION: The kitchen over range fill faucet leaked at the joints and was dripping.
- *Suggestion:* We recommend repair of the faucet. (See example picture in report body)

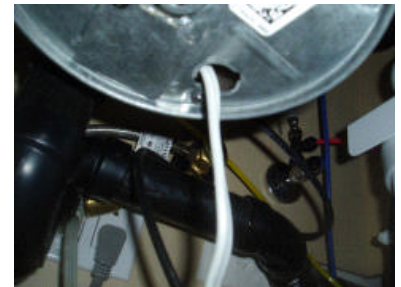
12.6 DISPOSAL WIRING:

ACTION: The power cord/wiring was not clamped to the disposal. This is a safety hazard.
- *SUGGESTION:* We recommend consulting a qualified specialist for advice and repairs. We recommend properly securing the disposal cord wiring. (See example picture in report body)

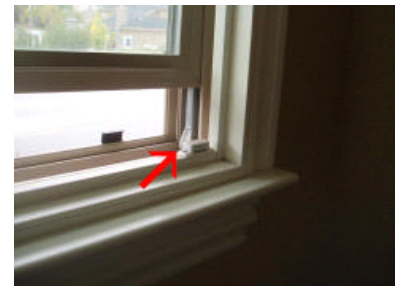
ACTION: [Safety item] A master bathroom water closet/toilet vertical sliding window was noted to have a damaged counter balance. This made the window difficult to use.

- SUGGESTION: We recommend repair of the window by a qualified window specialist. (See example picture in report body)

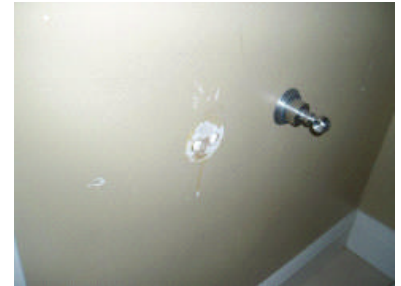
14.13 TOWEL BARS:

MAINTENANCE: There was no toilet paper holder installed. You may wish to install one of these devices. (See example picture in report body)

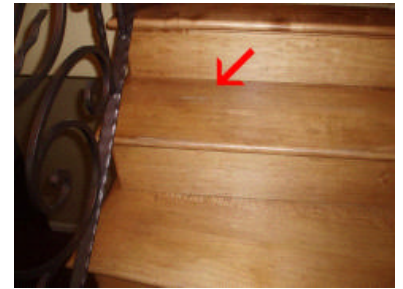
ACTION: [Safety item] The stair spacing was inconsistent and greater than 3/8's of an inch at the top tread. This condition is not according to industry standards and poses a trip hazard. Standard trade practices dictate that all steps be within tolerances for safety reasons.

- SUGGESTION: The stairs should be repaired or replaced by a qualified technician to conform to standard trade practices and reduce the potential for injury to persons who might use them. If the stairs are not modified or rebuilt, users of the stairs should exercise caution to avoid personal injury. (See example picture in report body)

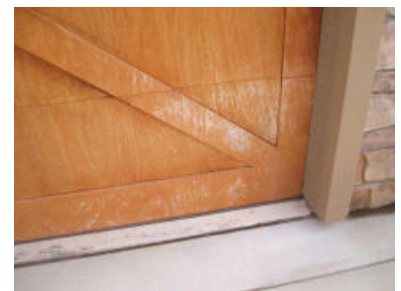
17.6 CAR DOOR(S):

MAINTENANCE: The car doors exterior finish was worn and peeling. We recommend routine staining/coating and maintenance to extend the life of the door. (See example picture in report body)
